Systems Engineering Investigation of Navy Electrical Bomb Fuzing

Gary A. Evans (Naval Air Warfare Center, Patuxent River, Maryland)

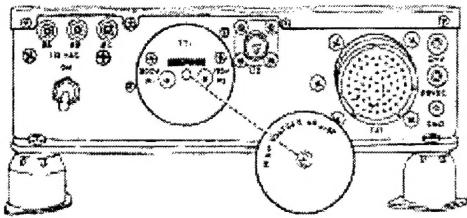
Figure 6
AWW-4

The AWW-4, Figure 6, provides electrical fuzing power to the fuze via several safety interlock devices. It is used in F/A-18 Lot 18 and below aircraft. Its mean time between failure (MTBF) rate was found to far exceed its specification. It has a record in the F/A-18 aircraft of over 2000 flight-hours/maintenance action for a recent 3-year period while only specified for a MTBF of 1000 hours. Its power output is specified at 500ma, which is powerful enough to provide an arming signal to several weapons simultaneously.

AWW-4 and wiring malfunctions were also evaluated. The F/A-18 does not currently perform a built in test (BIT) to verify the AWW-4 is functioning properly. This has the potential to allow an electrically fuzed bomb to be released unarmed if an unknown malfunction is present. Current electrical fuzing checks for available power at the bomb rack are not required unless an

One difference found between the AWW-4 and the SMUG SMP was short circuit recovery time. The ability of the AWW-4 to recover from a transitory short circuit was less than 2 milliseconds (ms) while the SMUG SMP found in current production F/A-18 aircraft is greater than 10ms. This was not a requirement that was specified for either the AWW-4 or the SMUG. A transitory short circuit condition can occur with an out of tolerance Mk-122 Safety Arming Switch. This can happen when the switch stab plunger penetrates the EMI shield if the insulation on the plunger is not of the specified length. Only one instance of this has been documented in several hundred ground tested switches. The 10ms short was not long enough to dud a 1000 or 2000 lb bomb by itself on a parent station. Because of the increased ejection velocities it could dud a 500 lb bomb on a parent station or a 500/1000 lb bomb on a Canted Vertical Ejector Rack (CVER).

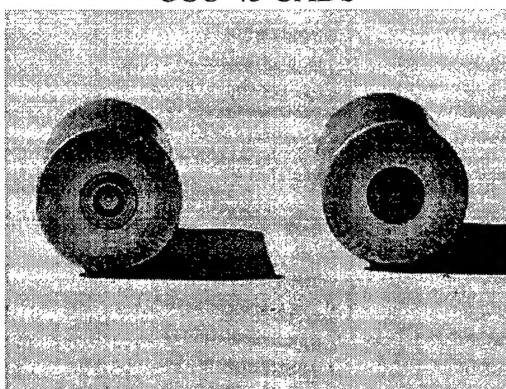
Figure 7
CCU-45 CADS

As part of the systems engineering evaluation, the effect of CCU-45, Figure 7, and delayed ignition was analyzed to determine if it could contribute to electrical fuze duds. Lot and random sampling test data were compared to CAD performance specifications. Lot tests indicated CCU-45s are performing within the specification.

Data analysis from several hundred F/A-18E/F weapon releases using CCU-45s also did not identify any problems. This was verified by subtracting the bomb rack operation time from the CAD spec values shown in Table 1, which contains the CCU-45 specifications. Ignition delay time plus bomb rack ejector piston end of stroke was less than 110ms in all cases for Mk 82, 83, and 84 bombs.

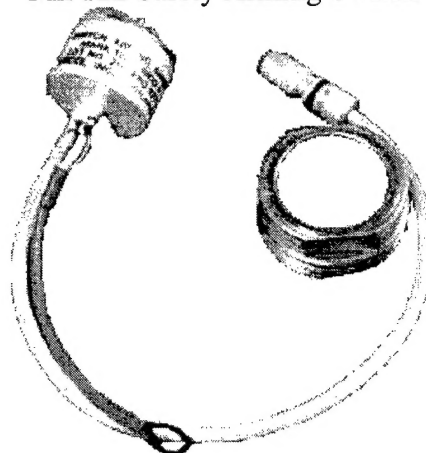
Figure 8
Mk 122 Safety Arming Switch

The Mk 122 Safety Arming switch, Figure 8, was developed in the early 1960's. It transfers aircraft fuze power to GP bombs. It was developed when bombs were ejected with relatively low ejection velocities compared with modern bomb rack units (BRU) such as the BRU-32 on the F/A-18 and F-14. The Mk 122s were first produced in March of 1963 and the last lot was produced in 1975. The majority of the remaining inventory of switches was manufactured between fiscal years 1970 and 1973.

The Mk 122 controls the available power connect time to charge the capacitor's fuze by the difference in length between two cables, the arming lanyard and co-axial cable. The difference in length is a nominal 7.175".

low resistance paths to ground (or short circuits) are allowed. The lanyard length is 5.875" +0.250/-0.188 and the Co-axial cable length is 13.050" +.000/-0.375. Several Aircraft/ Mk 122 interface factors were identified during this analysis that can reduce fuze capacitor charge time and contribute to or directly cause a bomb to dud.

The majority of Mk 122 inventory is almost 30 years old. Switch function may be impaired by lubricant used in the switch that has degraded and migrated into areas of the switch it was not intended for. Original tests designed to verify the switch performance are no longer valid due to sticking brought about by age. Limited on-aircraft F/A-18 & AV-8B ground tests of two switch lots identified switch closure times in excess of the specification time of 2.5ms. Mk 122 Lot FII was greater than 4-5 ms and Lot TMC was greater than 7-7.5 ms. Switch delays reduce fuze charge time margin. Analysis of COPE data, figure 12, did not identify any particular critical lots of Mk 122 Safety Arming Switches.

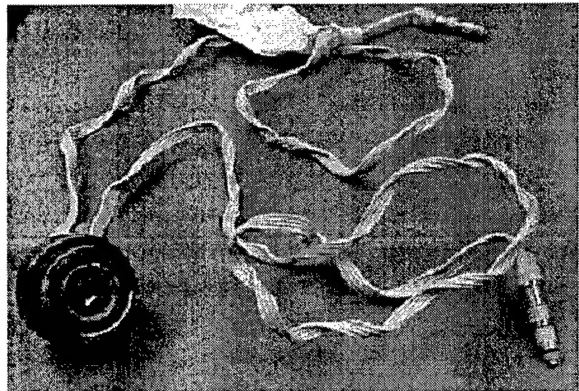
Figure 17
M70 Bomb
Cable

The M70 cable, figure 17, is routed inside Mk 80 series GP bomb body conduits. The cables are installed when the bombs are manufactured. Its purpose is to pass FFCS power from Mk 122 switch to the fuze. Testing of the cable prior to bomb assembly was discontinued due to high reliability. The only identified weak link was the cable spring clip / fuze interface, but no data exists to determine if this connector is presently contributing to the undetermined dud rates. As the inventory of bombs age, the potential for corrosion on connectors increases. Limited random sampling of test assets did not identify any problems. Therefore, the M70 cables at this time are not thought to be a significant contributor to electrically fuzed bomb duds.

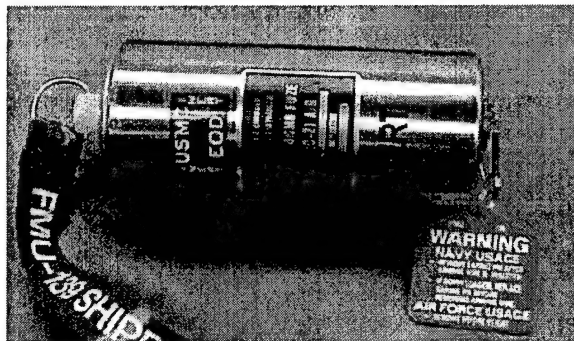
Figure 18
FMU-139 Electrical Bomb Fuze

The FMU-139 Electrical Bomb Fuze, figure 18 requires 15 ms of fuze function control set (FFCS) power to arm. It has been verified to function with less than the specification charge time, but its reliability is based on a full charge of 15 ms and without this it may not meet the specification operating life of 60 seconds. Most of the fuze power is used to reach arm time. Some

power is used after Arm Time is reached. The fuze capacitor is specified to have a 95mA max current draw. Tests have identified 80mA are typical. The fuze reliability specification is 95% reliability at a 90% confidence level. Based on Navy bench tests the fuze has demonstrated a 98.3% reliability at a 90% confidence level well above the specified value. These tests however were performed without the booster installed. Controlled aircraft flight tests performed by the U.S. Air Force also show the FMU-139 to exceed the specification at 97% reliability at a 90% confidence level. Therefore, when the fuze is given the proper minimum required charge profile and duration of 15 ms both the Navy and Air Force experienced similar reliability at a 90% confidence level using different test methods.

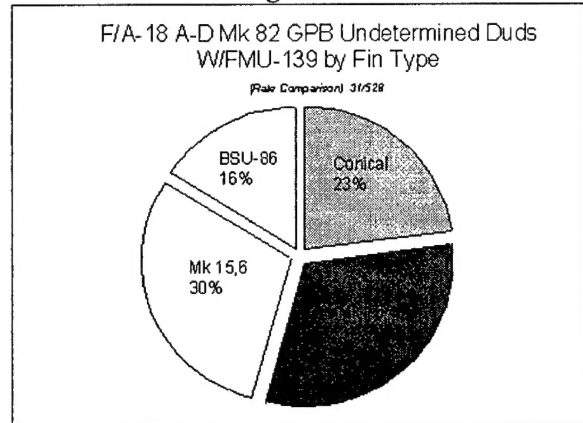
Figure 21

The effect of different bomb tail sections was also analyzed as part of the investigation. Undetermined dud rate data was correlated by bomb tail section for Mk 82 bombs figure 21 and Mk 83 bombs figure 22. From this undetermined dud rate data it was determined that any major source of unknown duds seem to be independent of fin type. BSU-86 and Mk 15 fin wire failures caused by fin blade movement do not appear to be excessive from training flight profiles that this data is taken from.

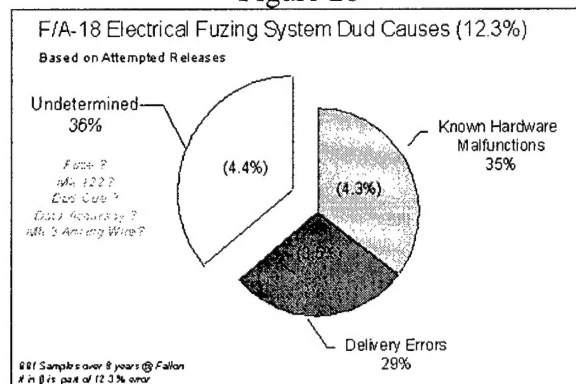
Figure 28

The F/A-18A thru D aircraft electrical fuzing system is at least 95% free of unknown failures. Zero to 4.4% of F/A-18 duds could be attributed to an unknown failure mechanism; however, it is highly unlikely. There is a high probability that the majority of the 4.4% of unknown failures depicted in figure 28 fit known hardware or delivery failure modes. Hardware issues such as fuze failures, Mk 122 cable routing, rack dynamics, tolerances, aging, and Mk 3 arming wire breakage combined with known delivery errors - too slow, time of fall, and dud cue tolerances leave little room left for any serious unknown root cause failure mechanisms to exist.
